# Explosion Accident during Mobile Production of Bulk Explosives

Report by DSBs project committee on the follow up of the accident in Drevja on the 17th of December 2013

Published by: Norwegian Directorate for Civil Protection (DSB) 2015

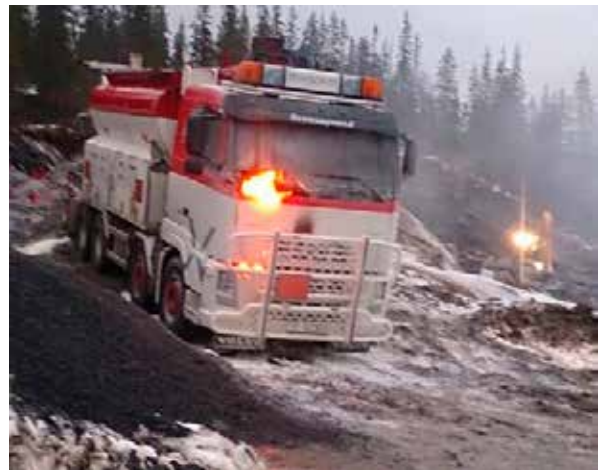
FIGURE 2. Picture of where the fire started.

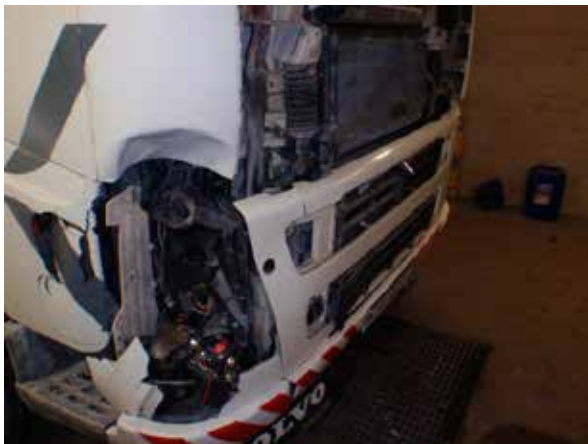
On 20th November 2013, F-114 was involved in a collision with three elks. The chassis received damages which were rectified in authorised garages, Volvo Car TTS and Dekksenter AS. There were damages related to the headlights and cables on the right side, to the car body and grille. Additionally a bull bar was fitted. The repairs were relatively comprehensive and in the order of 200,000 NOK. After the repairs, F-114 performed different charging missions. During these three charging missions, F-114 pumped a total of 26,895 kg without any non-conformances.

**FIGURE 4.** Picture of damages on MEMU F-114 after collision with the elks.

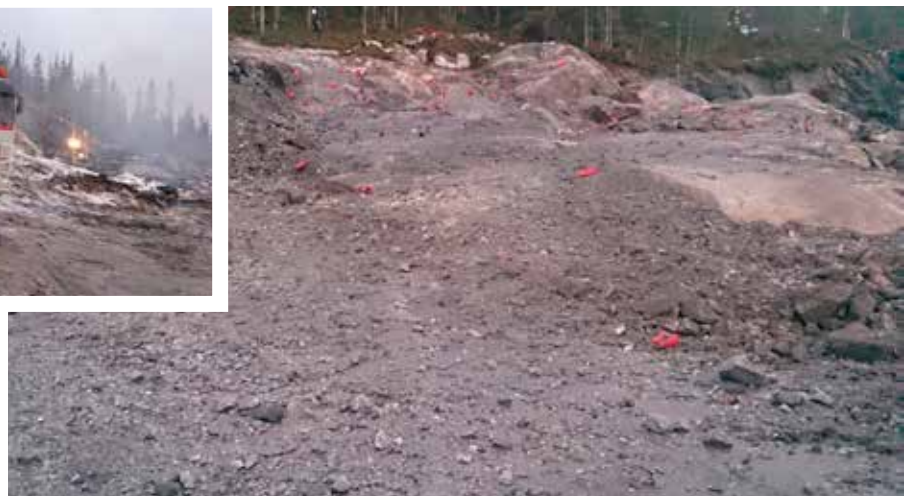
**FIGURE 9.** Explosion site after the explosion.

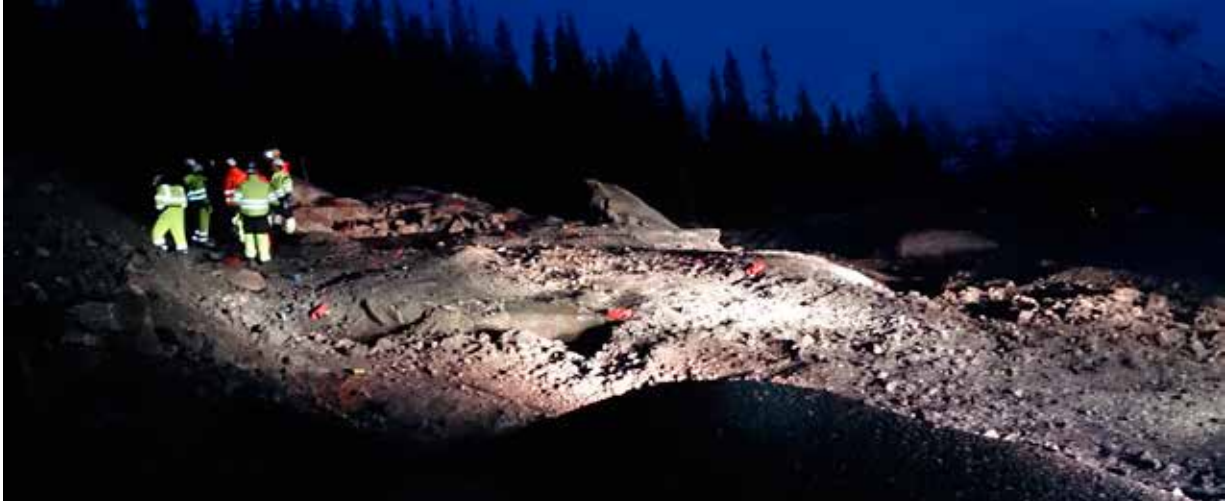
**FIGURE 10.** Picture that illustrates the effect of the blast on the crushed stones.

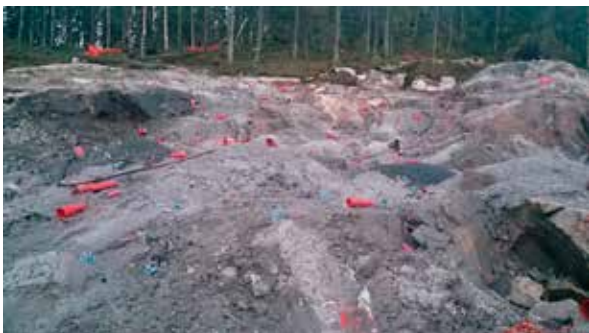
**FIGURE 11.** What it looked like on the blast area after the explosion.

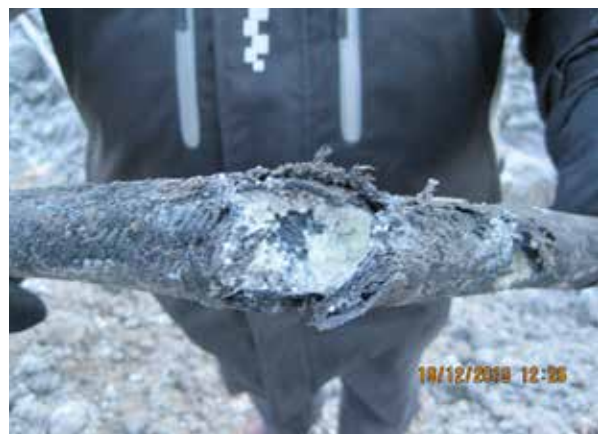
The hose which contained the mixed explosive material was found more or less intact approximately 40 meters from where the MEMU had been. The hose had a length of 84 meters in total where the first 60 meters starting at the outlet from the truck consisted of 1" reinforced rubber while the remaining 24 meters consisted of a 3/4" plastic charging hose which is lowered into the borehole. The content of the retrieved hose piece was sent to LOM (technical controlling authority) for analysis. The composition of the product was analysed, the sensitivity was tested according to the UN test series 3a and 3b and the thermal stability of the product was evaluated. The results were in conformity with the statement of compliance for the explosive RIOMEX SC 7000.

**FIGURE 12.** Picture of the hose with explosives.

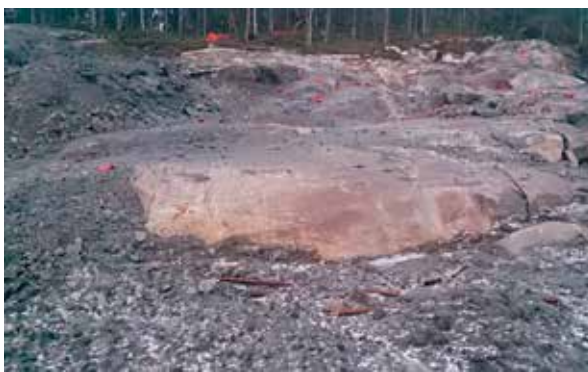
Figures 13 and 14 show that the rock surface at the explosion site had a distinct red coloring. The geologist from NPRA states that it is highly likely that this was caused by the incident.

**FIGURE 13.** Picture that demonstrates the red coloring on the rock surface.

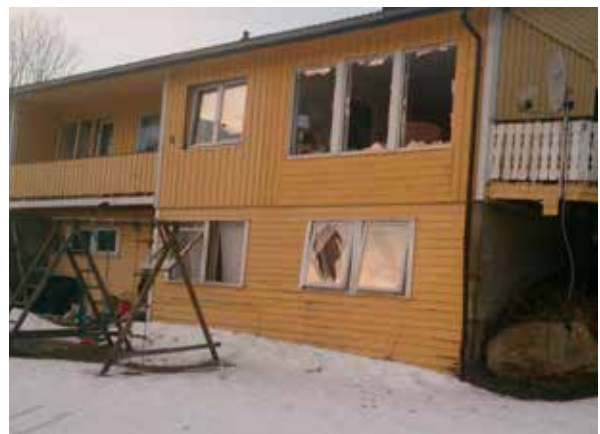
The pictures were analysed to find facades with several windows of the same type where only some of them were broken, since this indicates that the pressure and impulse values have been on the limit of what the windows can tolerate. The area and quality of the windows must then be evaluated in order to be able to estimate the pressure and impulse that the specific facade has been exposed to. A lateral pressure of 5 kPa can in most cases represent the pressure where windows can be broken. However, in some cases the pressure must exceed 10 kPa to achieve broken windows and some facades can even withstand pressure up to 15 kPa before 50% of the windows break.

**FIGURE 15.** Yellow house-wall facing south.

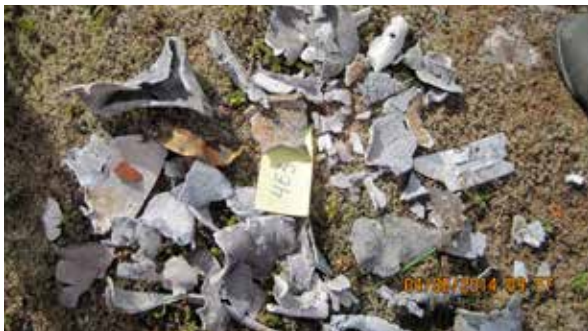
Small aluminum fragments, usually with a weight under 50 grams and an area down to 10 cm<sup>2</sup>, were found up to 200 meters away from the explosion site. Fragments of such a small size, will only travel this far if the metal has been in direct contact with the explosive, as stated by FFI. It is only possible to reach the necessary initial velocity for such a trajectory if the metal and explosive is in direct contact during the detonation. The initial velocity must have been close to 100 m/s, which corresponds to the Gurney velocity which is approximately 30% of the detonation velocity.

**FIGURE 20.** Small aluminum fragments found at approximately 150 meter in easterly direction.

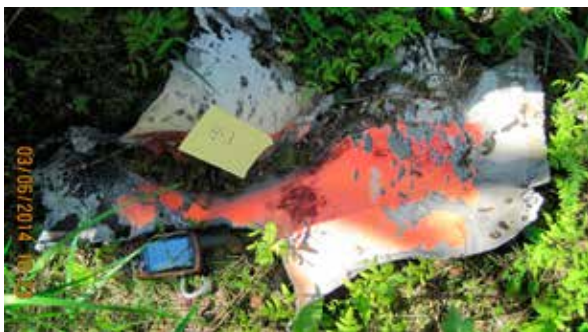
**FIGURE 21.** Big aluminum fragment found at approximately 170 meter in easterly direction.

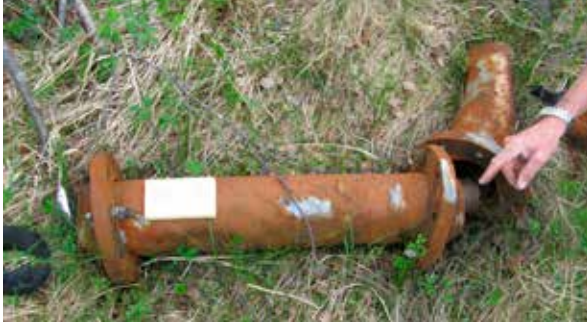
The augers and pump in the production unit is associated with explosive hazards if a pressure build-up caused by confinement is present. The product pump, the vertical auger and the horizontal mixing auger were all retrieved in a more or less intact condition and did not seem to have been exposed to any internal explosions.

**FIGURE 22.** Product pump.

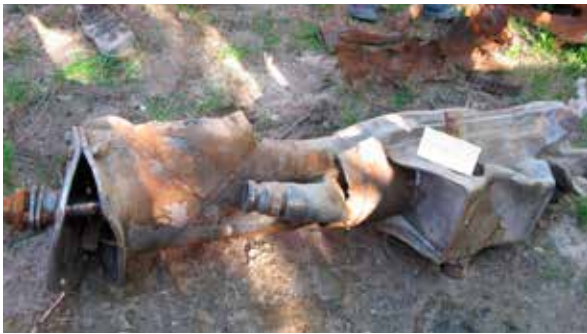
**FIGURE 23.** Horizontal mixing auger.

The product pump (approximately 80 kg) was found about 330 meters in a northwestern direction and the mixing auger (approximately 100 kg) was found around 500 meters in a southwestern direction from the explosion site. Even though the product pump in this case was not the cause of initiation, the project committee finds it important to stress that decomposition and pressure build-up in the pump when exposed to extreme heat could in theory lead to a detonation.

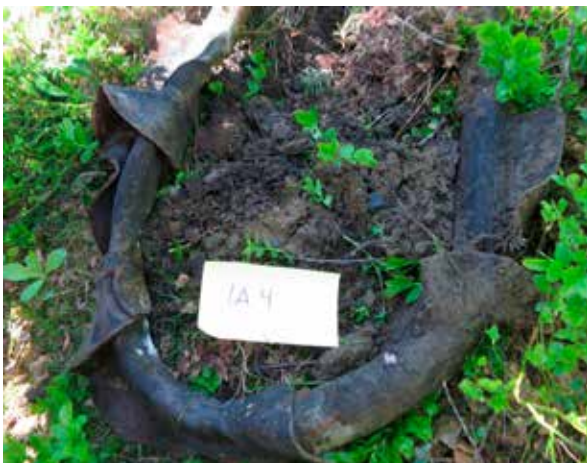
**FIGURE 24.** Part of the vertical auger.

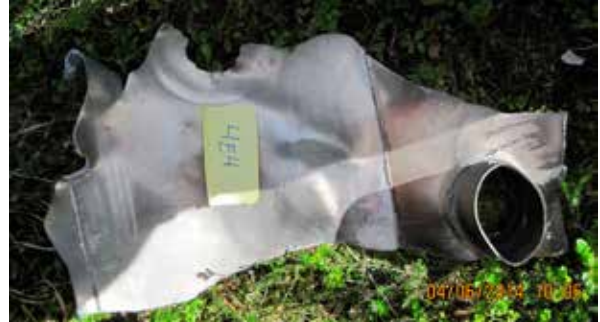
**FIGURE 25.** Fragment from the production diesel tank.

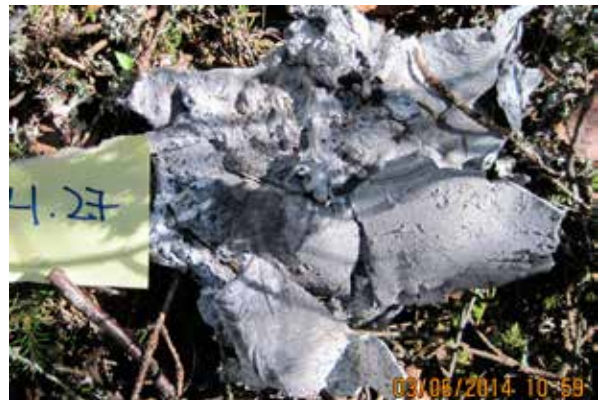
As mentioned earlier, roughly 115 aluminum fragments were identified (around 90 kg) originating from the tanks, cabinet doors, cab and the plate beneath the production unit. This is a small fraction of the total amount of aluminum that could be found on a MEMU. The tanks and the plate both had a thickness of 5 mm. Some of the fragments appeared to be unaffected by the heat from the fire while others were melted into aluminum cakes (28 were found in total). The evaluation on the heat influence on the aluminum fragments have been performed by engineers from DSB and an engineer from Maxam, Spain. Metallurgic expertise has not been performed.

**FIGURE 26.** Melted aluminium.

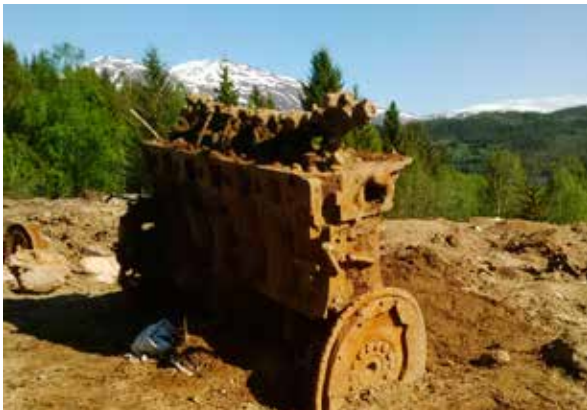
**FIGURE 27.** The engine block.

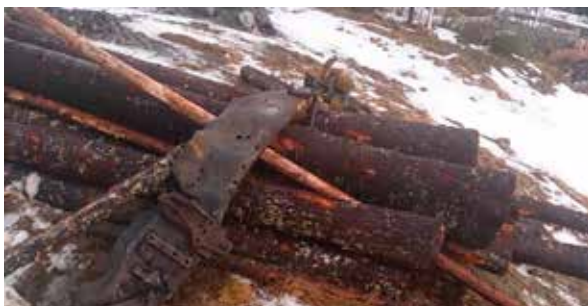
Another relevant issue is that diesel burns more intensively than e.g. rubber or plastic. This intensive burning will produce extremely high temperatures.

**FIGURE 28.** Fragment that illustrates deformation of steel due to heating.

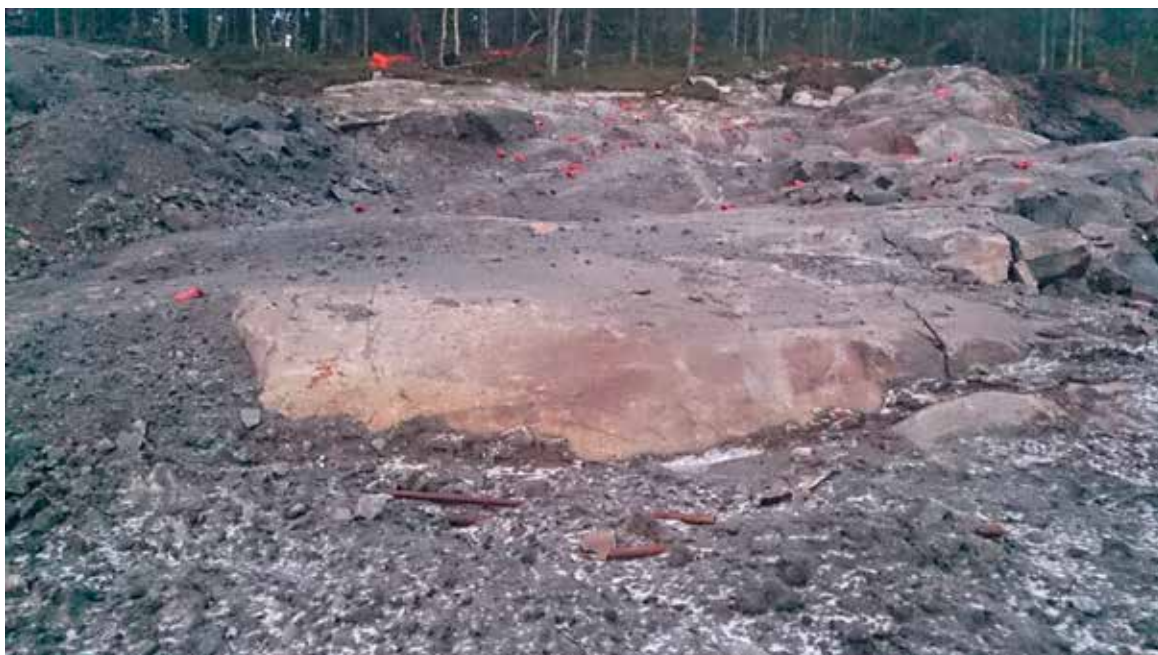
Foto 2: Bilde visende fjellparti rett bak der eksplosjonen skjedde. Bilde tatt av DSB den 18. desember 2013.

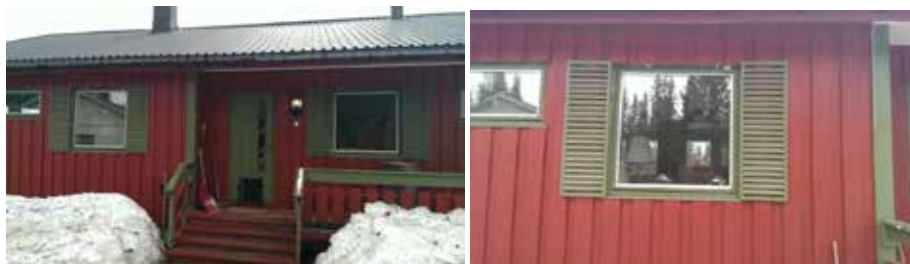
*Nordside. Vindu skjøvet inn. Kun vindu i dør som er knust.*

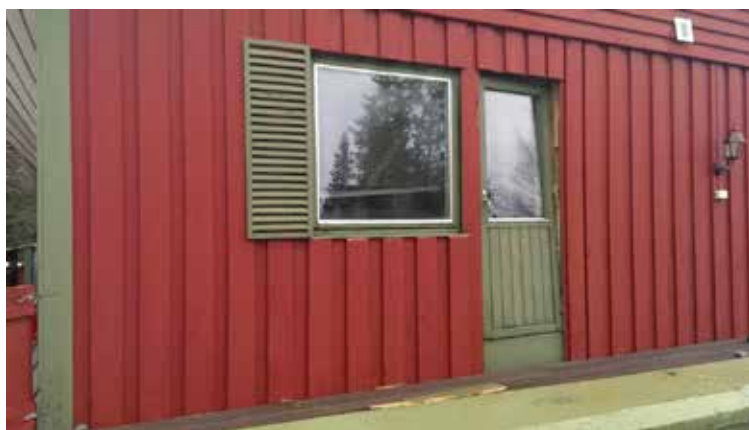
*Vestside. Dør presset inn.*

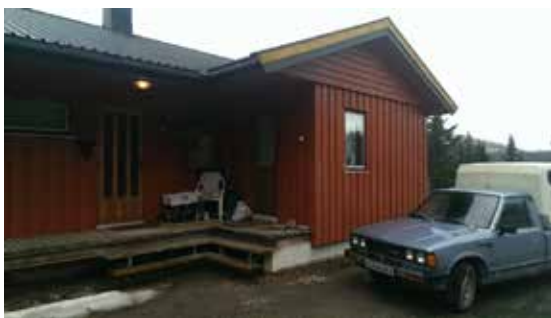
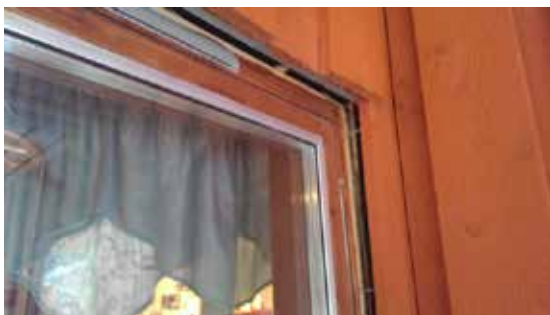
*Fasade mot nord. Ingen knuste vinduer, men skjøvet inn + strukturelle skader inne.*

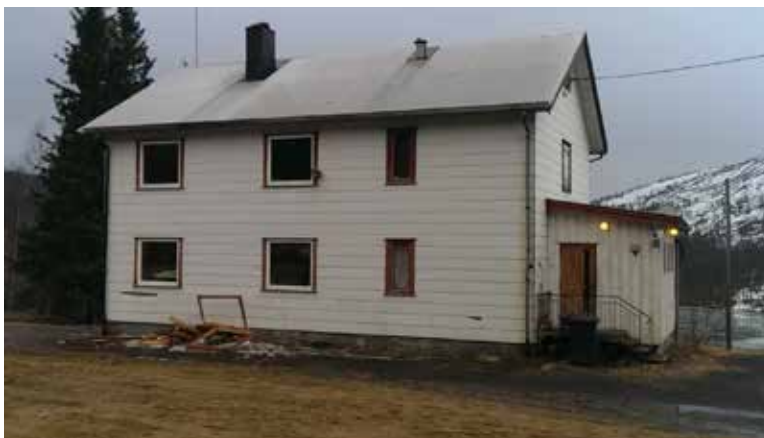
*Nordside. De fire store vindu knust, de to små hele.*
