# Explosion Accident during Mobile Production of Bulk Explosives

Report by DSBs project committee on the follow up of the accident in Drevja on the 17th of December 2013

Published by: Norwegian Directorate for Civil Protection (DSB) 2015

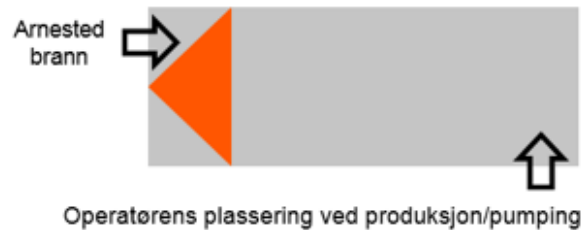
The production commenced at approximately 12:00. When initiated, the production starts first followed by product pumping. At this time the operator of the pump was situated by the cabinet on the left rear side of the truck, where the operator console for the production unit was placed (Figure 1). During production/pumping, the engine was running and the lights were turned on. Two RockNor employees were situated at the rear end of the vehicle close to the blast area, when the fire was discovered.

FIGURE 1. Where the operator stood in relation to the fire.

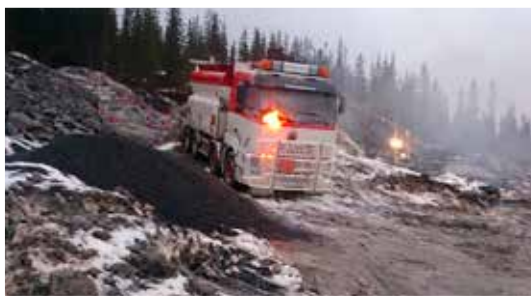
**FIGURE 8.** Explosion site before the explosion.

Figure 8 and 9 clearly demonstrates that the MEMU was considerably fragmented and that these fragments were immensely scattered by the explosion.

In Figure 8, a pile of crushed stones is seen to the left, next to and in front of the MEMU. During the first inspection on December 19th 2013, it was observed that this pile was less affected by the shock wave than what could be presumed. Figure 10 also illustrates this; however, it is difficult to give any accurate evaluations on these effects due to uncertainty in the distances at the site.

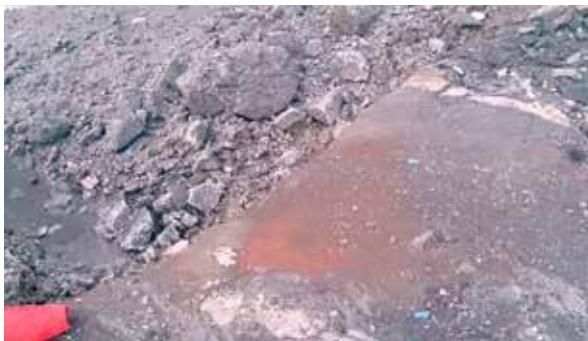
Figures 13 and 14 show that the rock surface at the explosion site had a distinct red coloring. The geologist from NPRA states that it is highly likely that this was caused by the incident.

**FIGURE 14.** Close up of the coloring.

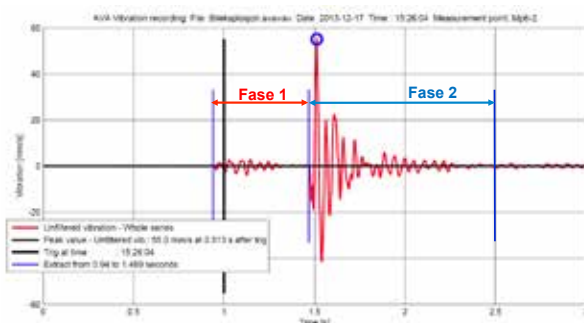
The measurements recorded during the explosion show two clearly separated phases – designated as

**FIGURE 16.** Registered seismographic measurements from the explosion in Drevja.

phase 1 and 2, respectively. NGI interoperate phase 1 to be vibrations which are transferred as mechanical waves from the explosion through the ground. Phase 2 are vibrations which are induced directly in and around the foundation when the air pressure from the explosion passes by.

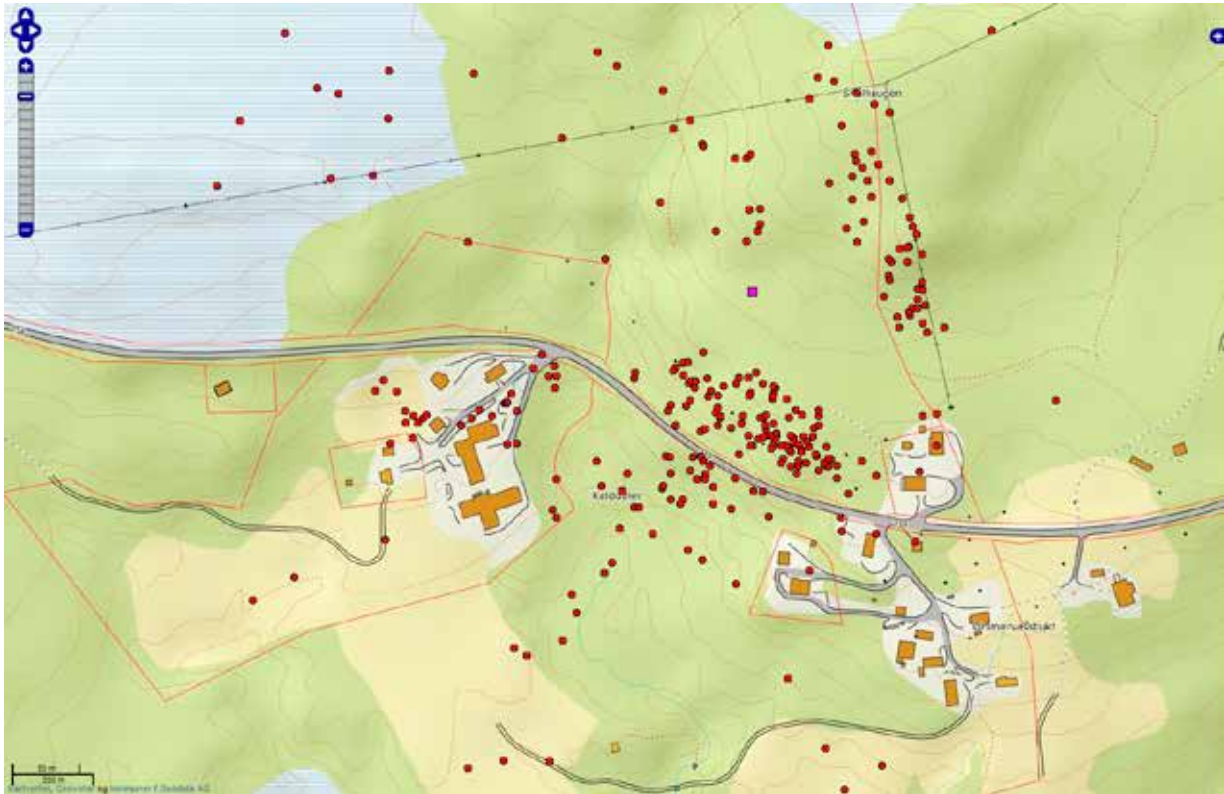
The fragments were found at distances from approximately 50 meters to around 500 meters. The map seen in the next figure shows a plot of all the registered fragments. The retrieved fragments varied considerably in weight, from aluminum fragments of a couple of grams to the engine block weighing around 900 kg.

Maxam has performed their own analyses based on the retrieved fragments as a part of their own individual report on this accident. Around 3,000 kg of the 9,000 kg of non-combustible material on the truck has been identified. Of these, around 30% of the total fragment count is aluminium, even though aluminium accounts for only 5% of the total weight. The remaining fragments are mainly of steel.

**FIGURE 18.** Map with plots of all the fragments. The pink square indicates the position of the MEMU.

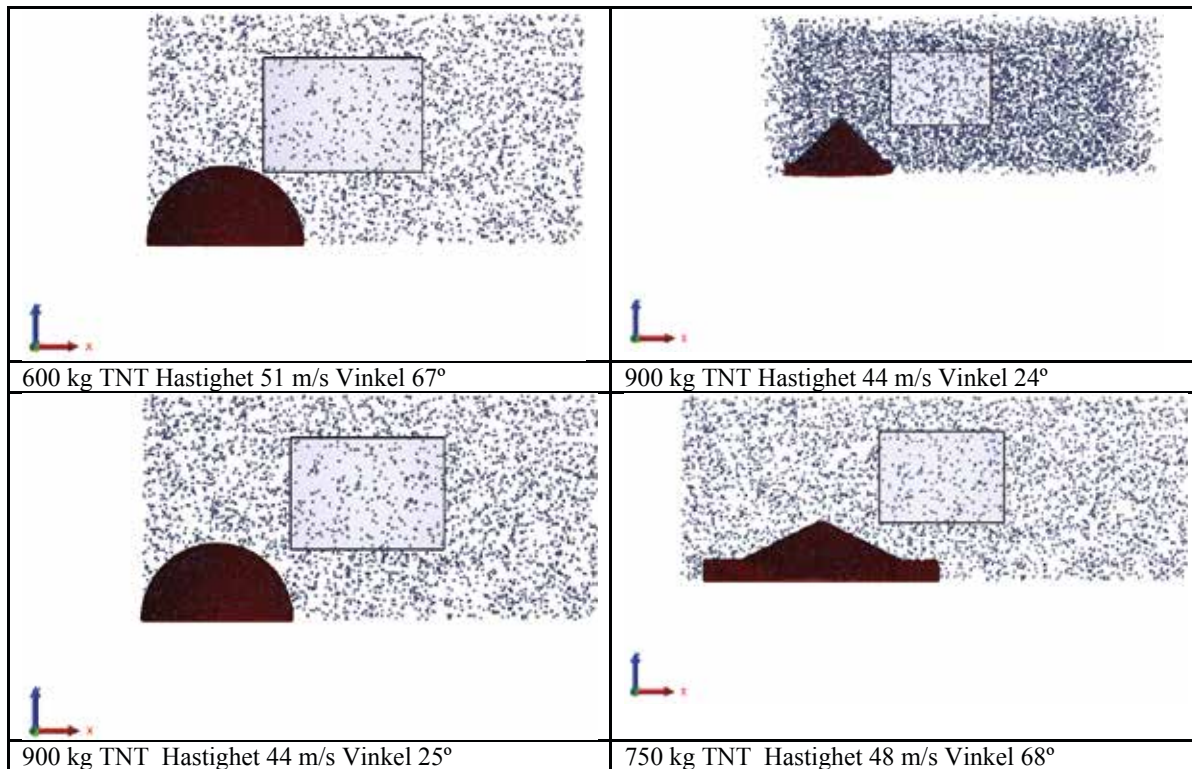
In the following figure, four different configurations can be seen where the combination of the shape, amount and positioning of the explosive and initial velocity and engine of the engine block provides the observed trajectory from the accident.

**FIGURE 19.** Four possible configurations that can result in the observed trajectory.

been used another outcome could be likely. A different configuration and positioning of the explosive could have shown different explosive yields. As an example, smaller amounts of explosive could have provided the necessary force if the explosive was partly placed directly beneath the engine.

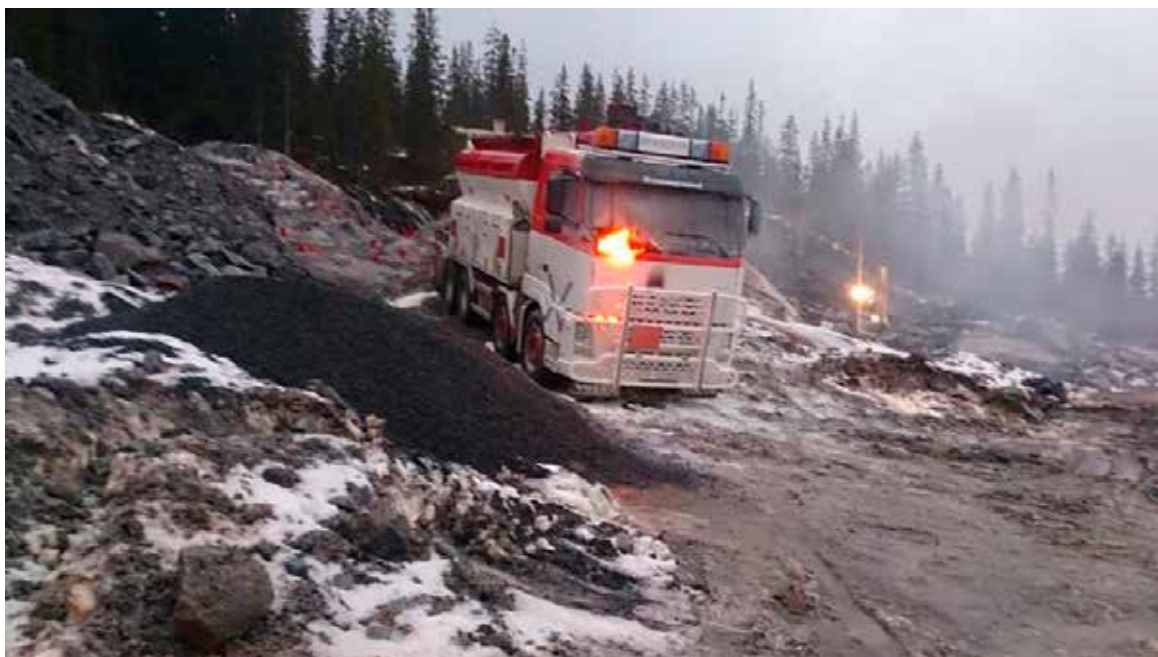
Rundt slurrybilen ved ulykken vart det liggende stein/pukk, se foto 1 i vedlegg 1. Disse steinene er trulig de steinene som vart flyet i lufta og som truffet nærliggende byggen.

Foto 1: Slurrybil før eksplosjon den 17. desember 2013. Bilde mottatt fra DSB.

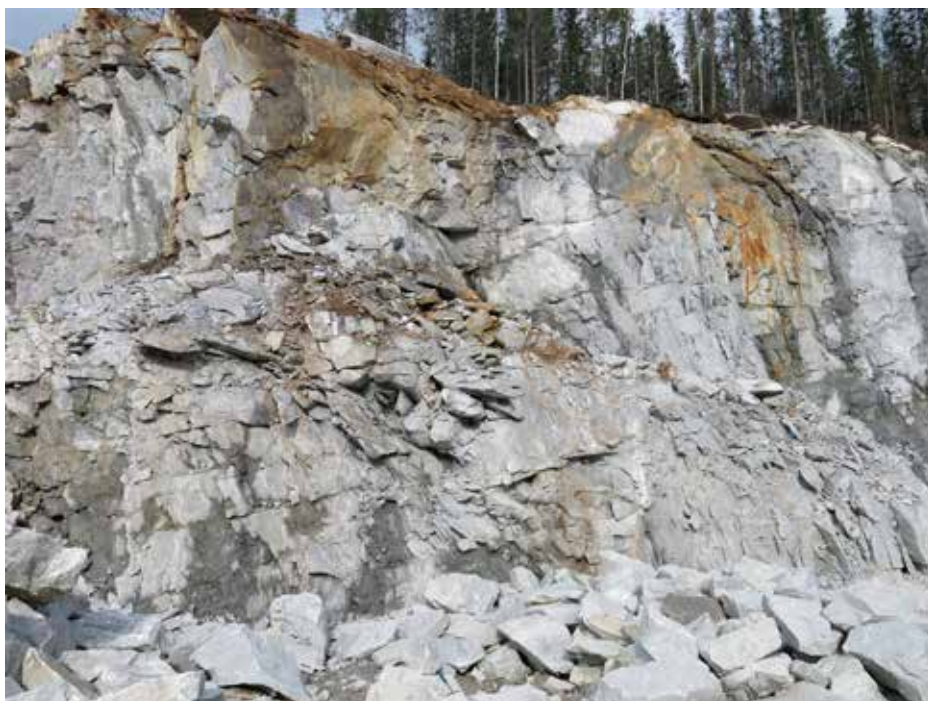
Foto 5: Bergvegg rett nord for der eksplosjonen skjedde. Hammer i nedre delen av bilde viser ca. hvor eksplosjonen vart. Bilde tatt den 25. september 2014.

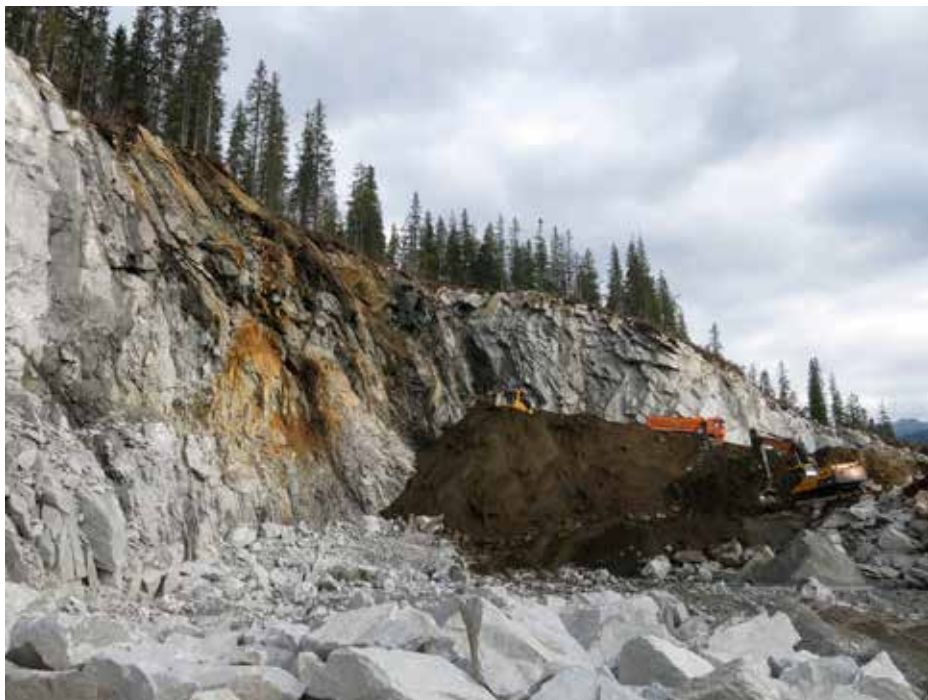
Foto 6: Sett fra eksplosjonssted mot fjellvegg i nordøst. Mørke fjellet er svakhetssonen som korse masseuttaket. Bilde tatt den 25. september 2014.

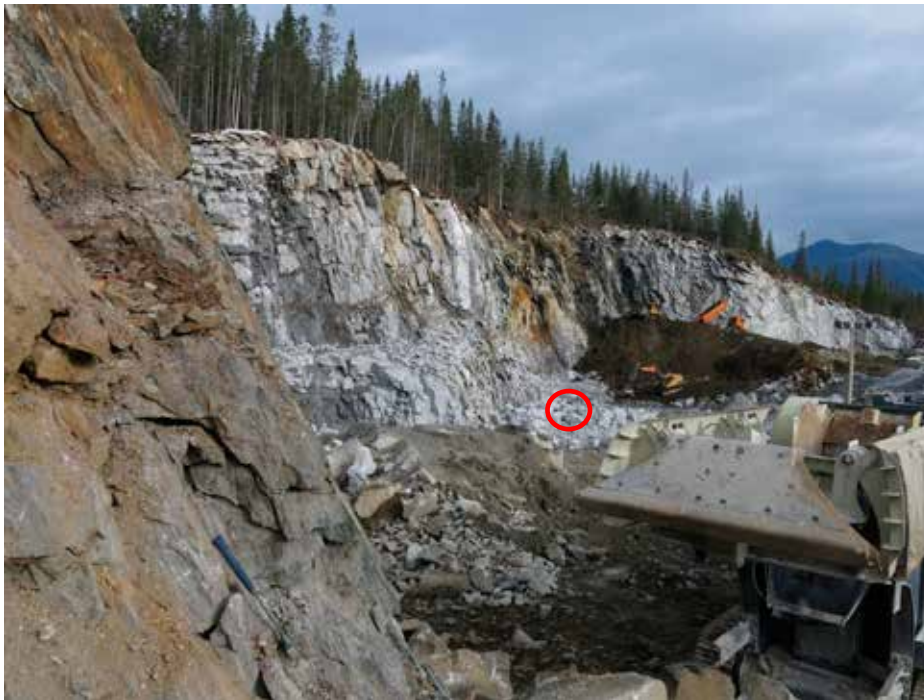
Foto 7. Bilde tatt fra pel ca. 4 810 mot nordøst. Fjellveggen sett på venstre side av bilde er av samme type berg som svakhetssonen sett på avstand, se foto 6. Stedet for eksplosjonen er omtrentlig innringet med rødt i bilde. Bilde tatt den 25. september 2014.

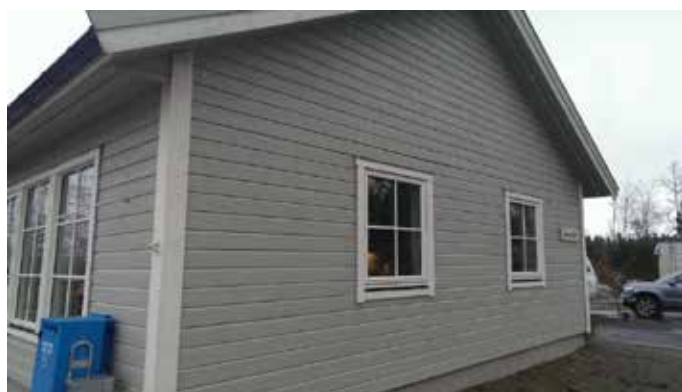
Ingen skader verken på kortvegg eller langvegg.

Grått hus. Hjørne mot ES.

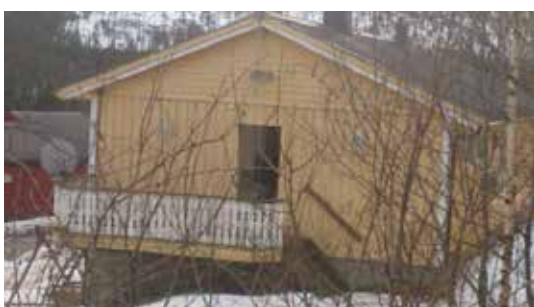
Kun dør på kortvegg. Blåst inn.

*Kortvegg mot øst og ES. Dør blåst inn.*

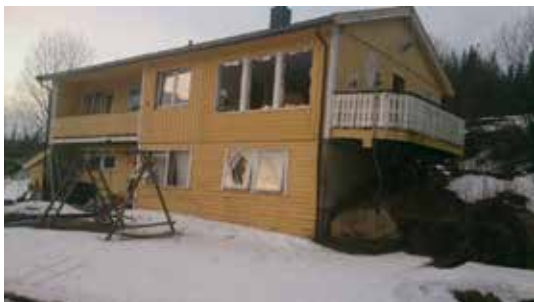
Langvegg: Tre av tre store vinduer knust. Halvparten av ”husmorsvindu” i 1.etg knust. Vindu i 2.etg skjøvet inn.

*Langside mot sør. Vinduer knust. Vinduer skjøvet inn.*

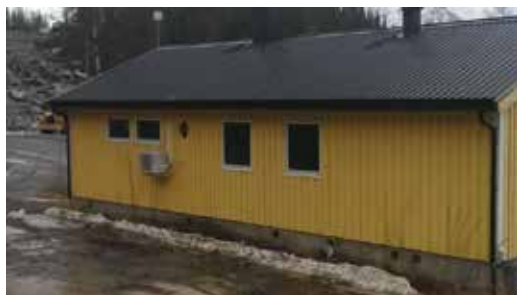
*Langside nord. Ingen skader. ES opp til venstre.*

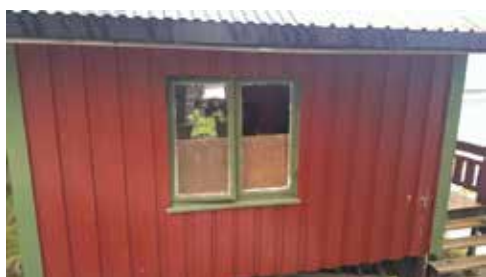
*Bilde fra vest. Ett av to vindu knust. (Skjernet av typografi/vegetasjon?)*

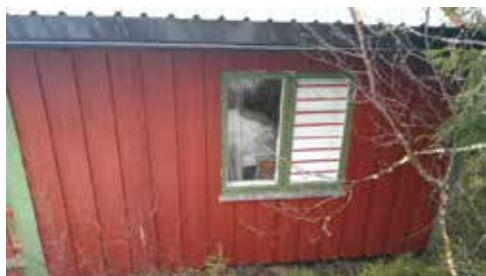
*Bakside. Begge vindu hele.*

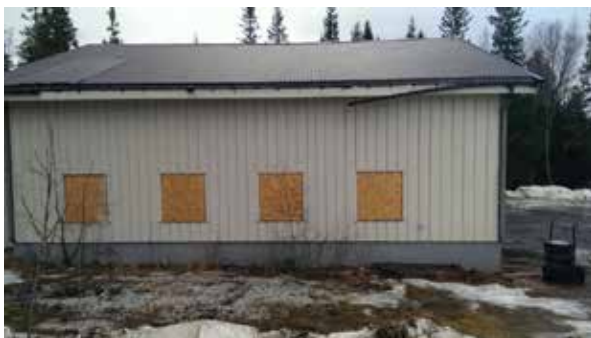
*Langvegg mot vest. Fire av fire vindu knust. Takrenne henger.*

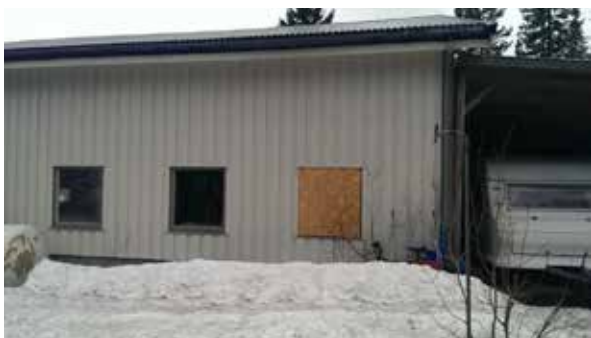
*Bakvegg mot øst. Ett vindu knust (blåst eller sugd ut).*

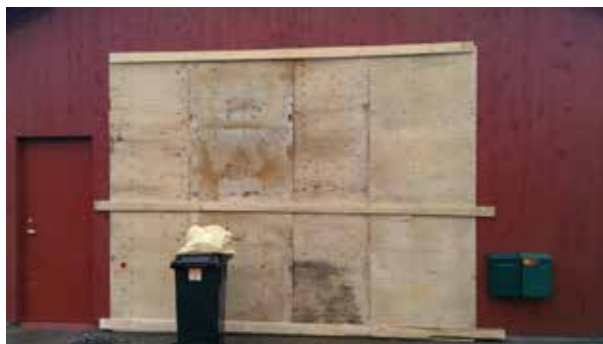
*Vegg mot nord. Port trykket inn.*

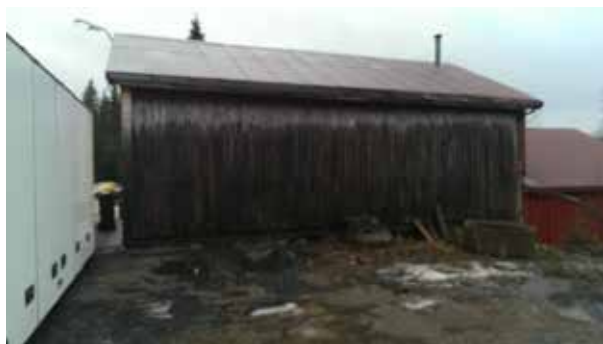
*Sidevegg mot vest*

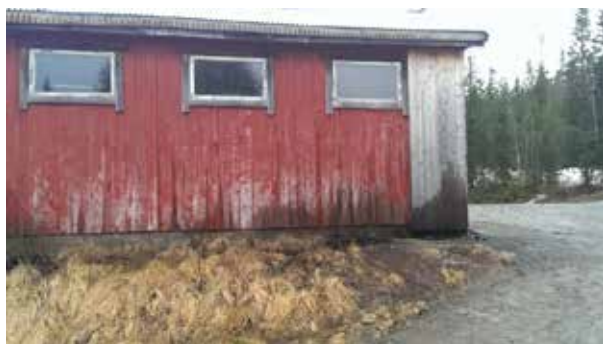
*Sidevegg mot øst med vindu. Ingen knust.*

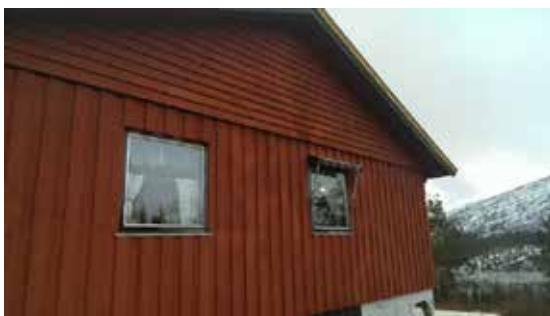
*Fasade mot vest.*

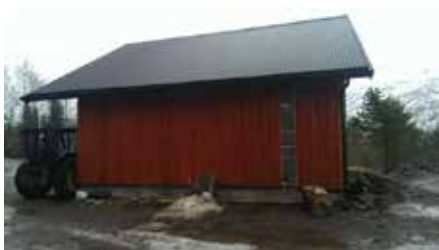
Fasade mot nord, avstand 202 m, refleksjonsvinkel ca 8 grader.

*Fasade mot nord.*

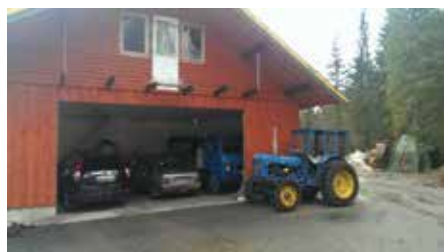
*Fasade mot øst. Dør 2. etg vippet frem.*

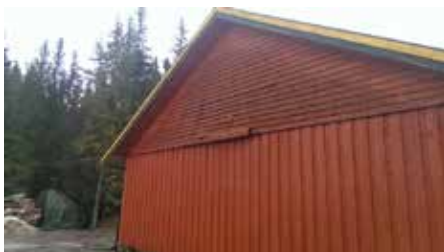
*Fasade mot vest. Vegg buler.*

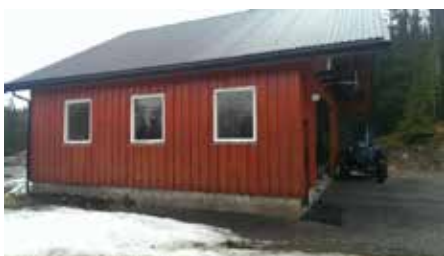
*Fasade mot sør (bakside)*

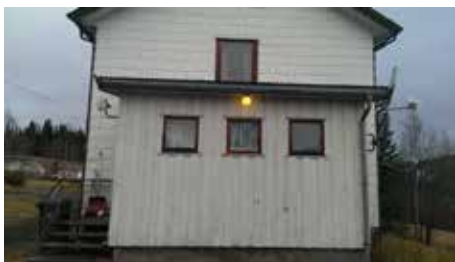
*Vestvegg. Alle vinduer hele.*

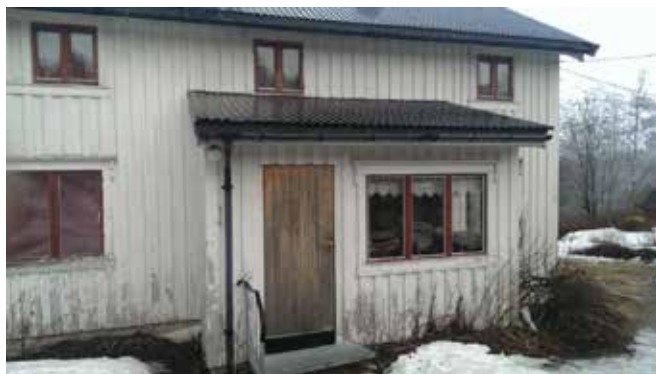
Fasade mot nord, avstand ca 337 m, refleksjonsvinkel ca 45 grader.

*Fasade mot nord. Ingen skader.*

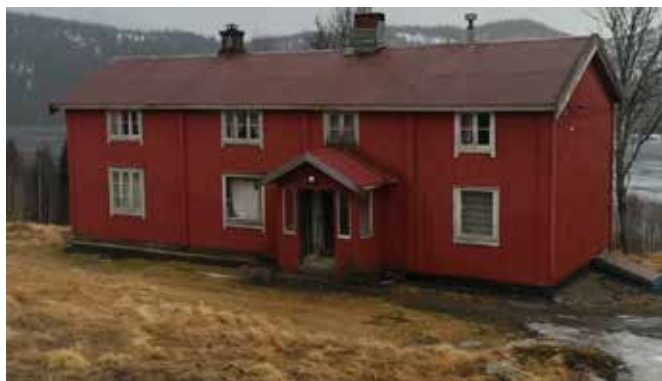
Langvegg mot nord, avstand 357 m, refleksjonsvinkel ca 30 grader.

*Fasade mot nord. Ingen vindu knust (nå).*

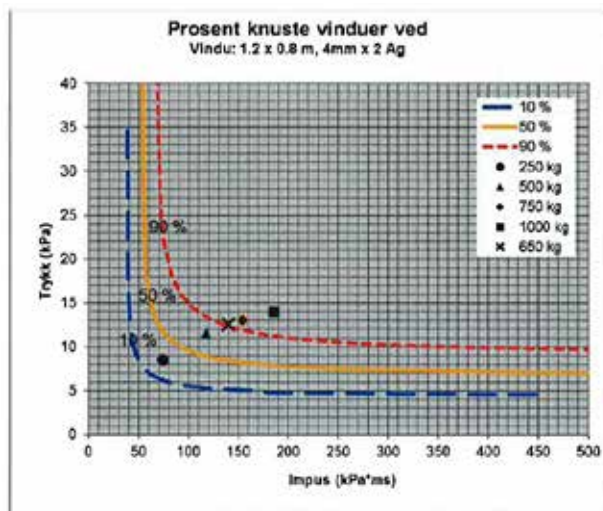
Resultat plottet for vindu 1,2 m x 0,8 m, 4 mm vanlig glass:

Statistisk grunnlag for % andel knuste glass er dårlig, men det at tre av tre store vinduer knuste støtter at ladningen var på mer ca 700 kg TNT. Det ser imidlertid ut til at vinduene er noe større enn 1,2 x 0,8 m. Dette gir noe lavere motstandevne og lavere minimumsmengde for å knuse.

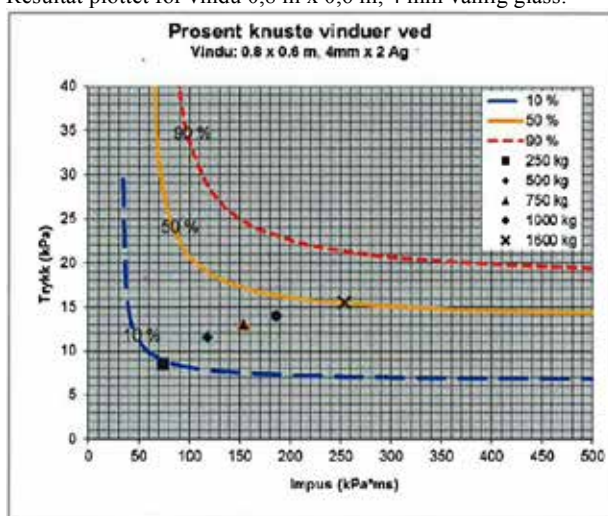
Resultat plottet for vindu 0,8 m x 0,6 m, 4 mm vanlig glass:

Ca 50 % knusing av de minste vinduene gir indikasjoner på at om de var på 0,8 x 0,6 meter så var mengden ca. 1.600 kg. Imidlertid ser også disse ut til å være noe større. Vurderes 50% knusing i 1,2 x 0,8 m PI-kurven, så indikerer det mellom 250 og 500 kg TNT.

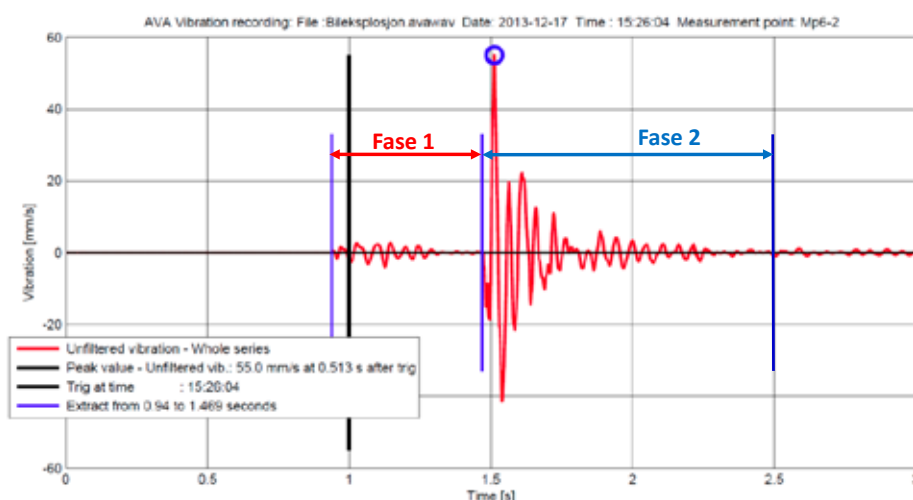
Figur 1 Registrert vibrasjonsforløp fra eksplosjon ved Dervja 17. desember 2013

Figur 1 viser vibrasjonsforløpet fra eksplosjonen, slik det er registrert av sensoren på grunnmuren i PM6-2.

Fra plotten i Figur 1 kan vi lese av følgende målte differanse i ankomsttid til:  $t_{diff\_m\ddot{a}lt} = (t_{trykk\_m\ddot{a}lt} - t_{vib\_m\ddot{a}lt}) = (1.464s - 0.935s) = 0.529s$ . Dette stemmer svært godt med den beregnede forventede forskjellen i ankomsttider. Det gir på denne måten en strek indikasjon på at vår tolkning av det registrerte vibrasjonsforløpet, at den første fasen – Fase 1 er mekaniske bølger, overført direkte gjennom bakken som Rayleighbølger, og at den andre fasen – Fase 2 er en umiddelbar respons av leire og grunnmur på ankomsten av lufttrykkstøtet fra eksplosjonen.

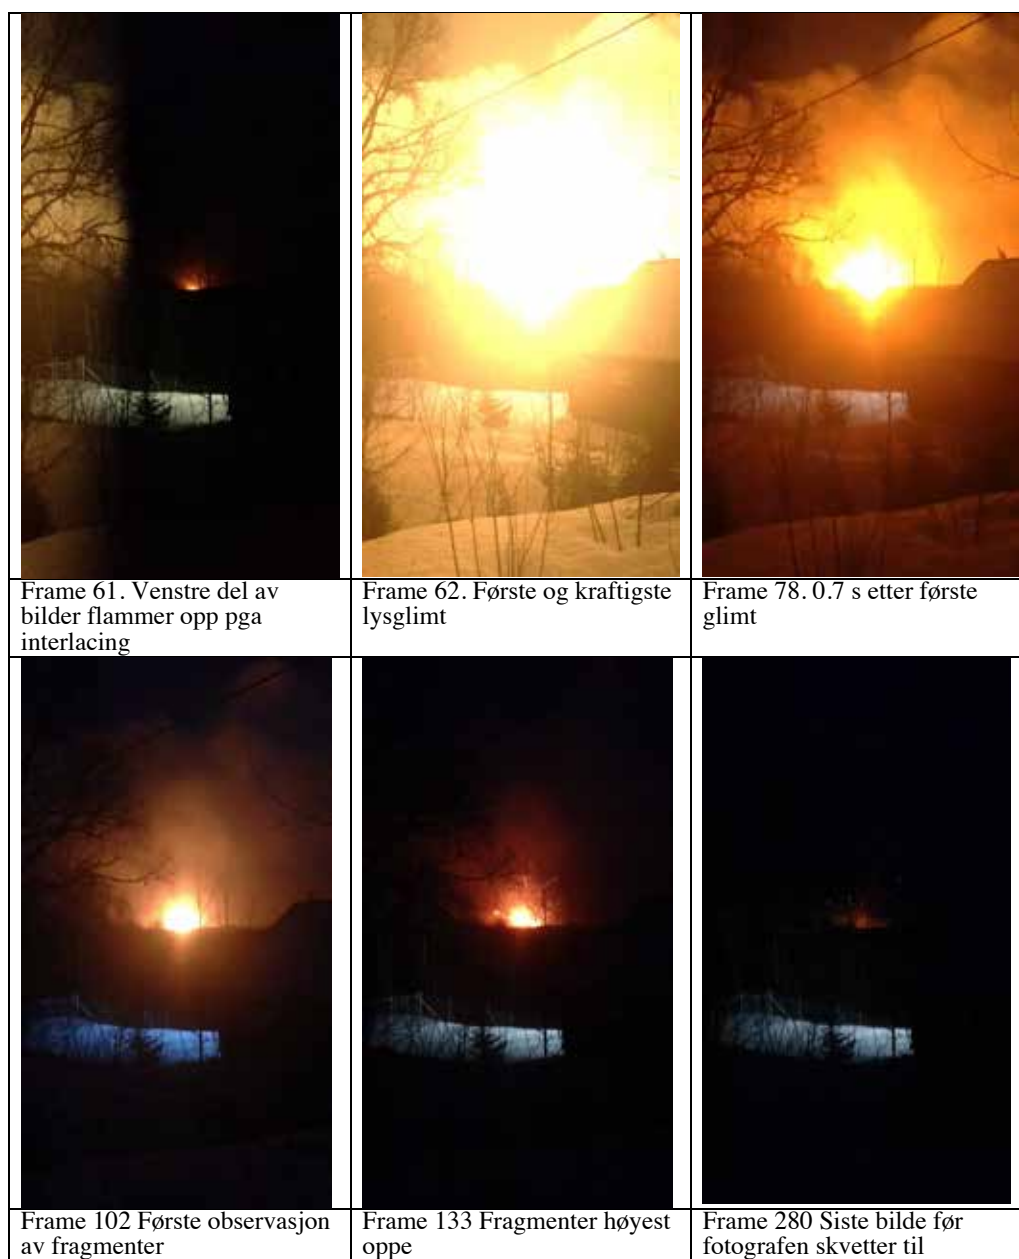
Figur 1 Utvalgte bilder fra videoopptaket.

Det er derfor mest sannsynlig at det dreier seg om stålfragmenter på noen hundre gram. Et fragment på 300 gram kan nå denne høyden dersom utgangshastigheten er ca 700 m/s. Det vil nå toppunktet etter ca 6,5

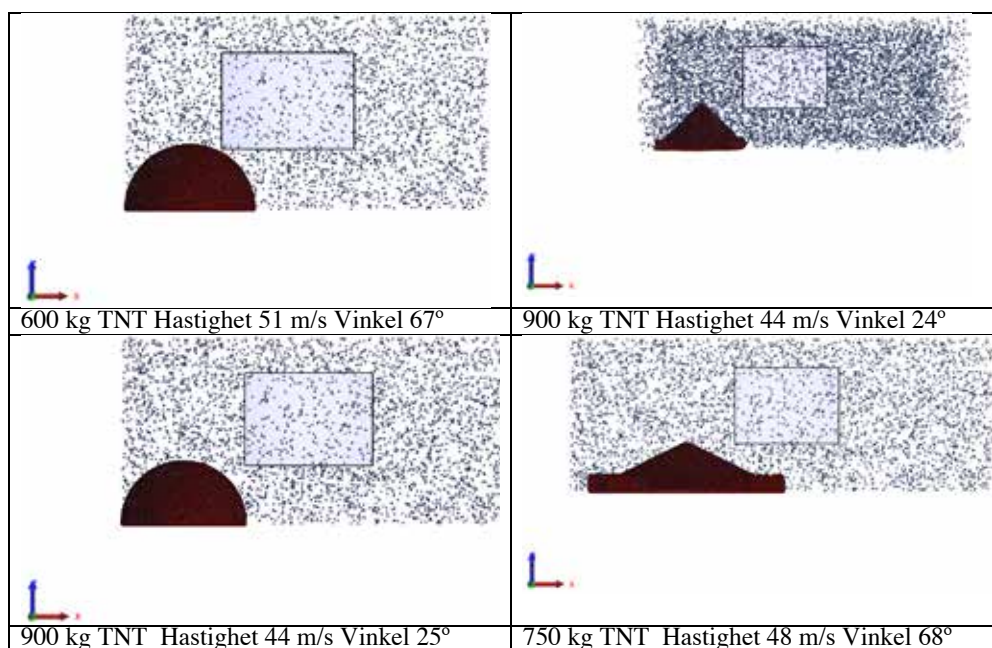
Figur 3 viser fire konfigurasjoner hvor resultatet, i form av sprengstoffmasse, utkasthastighet og utkastvinkel, blir slik at motorblokken ville ha landet på funnstedet.

Figur 3 Fire mulige konfigurasjoner som gir mulig løsning for motorblokkens utkast.

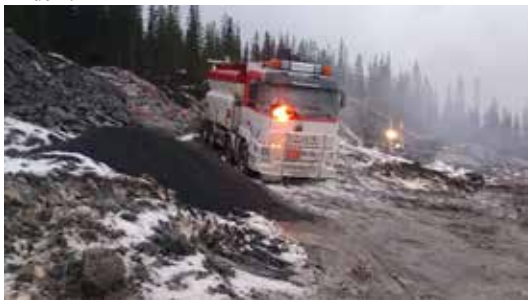
<ul style="list-style-type: none"> <li>• Viser brannens arnested.</li> <li>• Flammer på høyre side av F-114 under frontruten og i tillegg er det to mindre flammer lengre ned på denne siden, ved grillen.</li> <li>• Rundt midten av fronten er det en tydelig avsetning av sot på oversiden av grillen.</li> <li>• Lyskasteren til høyre for bilen ble ikke slått av før evakuering.</li> </ul>
kl 13:26 Brannen har vart i ca. 22 min.	Bilde 2:

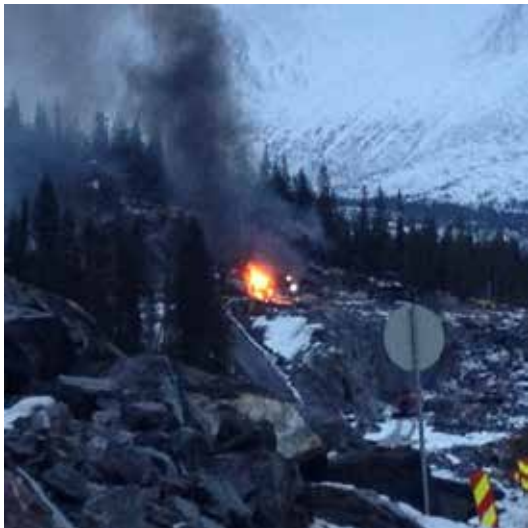
<ul style="list-style-type: none"> <li>• Førerhuset er i full brann.</li> <li>• Ingen flammer på lasteplanet, deksel ses tydelig.</li> <li>• Ser ut til å brenne på bakken foran bilen.</li> <li>• Sort røyk kan tyde på forbrenning av plast, gummi, diesel og olje.</li> <li>• Lyskasteren ses til høyre for brannen.</li> </ul>

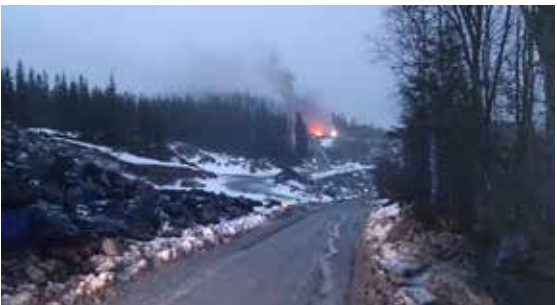
<p>Røyken er nå mindre sort og mer grå. Det kan tyde på at det er vanndamp i røyken. Vanndamp vil kunne gi hvit røyk, men sammen med sort røyk fra forbrenning av hydrokarboner kan røyken se mer grå ut.</p>
<p><b>Kl 14:23</b> Brannen har vart i ca. 1t 19 min</p>	<p>Bilde 4:</p>

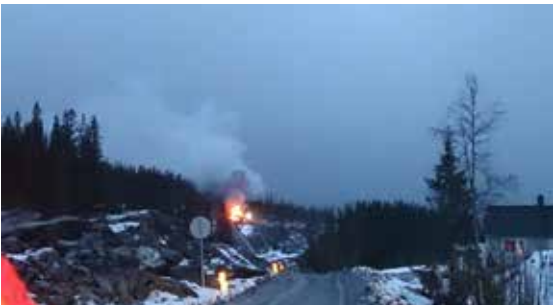
<p>Røyken ser mer grå og hvit ut enn på bilde tatt kl 14:06. Som nevnt tidligere kan hvit røyk tyde på at det er vanndamp i røyken. Vanndampen kan stamme fra både vanntanken på lasteplanet men også fra dekomponering av ammoniumnitrat.</p>
<p><b>Kl 14:30</b> Brannen har vart i ca. 1t 26 min</p>	<p>Bilde 5:</p>

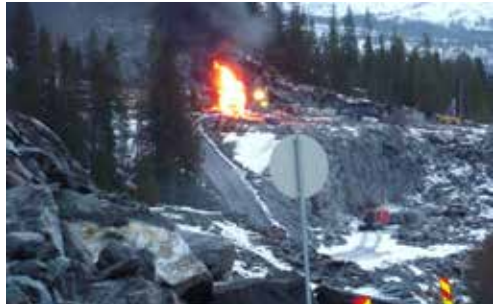
<p>Ser ut som brannen ikke har nådd enden av lasteplanet, men at de bakerste bildekkene brenner.</p>
	<p>Bilde 5 zoomet:</p>

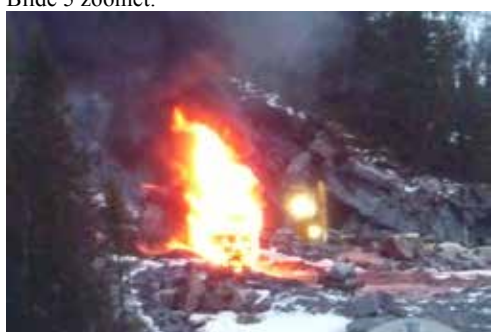
<p>Ser ut som det brenner på bakken foran og ved siden av bilen. Kan være diesel, olje, smeltet plast og bildekk. Kan også tenkes å komme fra kjemikalier fra tankene om bord som har rent ut og brenner enten alene eller i kombinasjon med de tidligere nevnte materialer.</p>

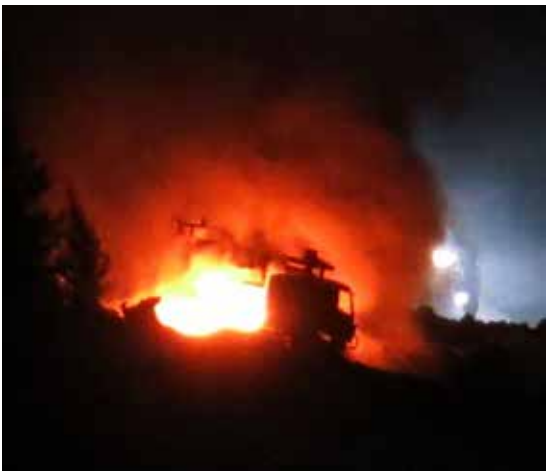
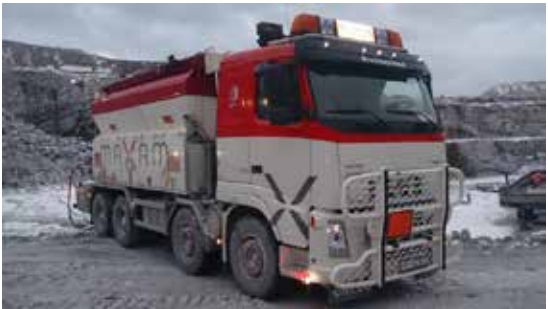
<p><b>K1 15:15</b> Brannen har vart i 2t 7 min</p>	<p>Bilde 6A:</p>

<ul style="list-style-type: none"> <li>• Ser ut til at førerhytta er utbrent.</li> <li>• Produksjonsenheten på lasteplanet er omsluttet av brann.</li> <li>• Ser ut til at horisontal skrue har falt litt ned når man sammenligner bilde 6A og 6B. Tyder på svikt i bæreegenskapene til aluminiumstankene.</li> </ul>
<p><b>K1 15:21</b> Brannen har vart i 2t 17 min</p>	<p>Bilde 7:</p>

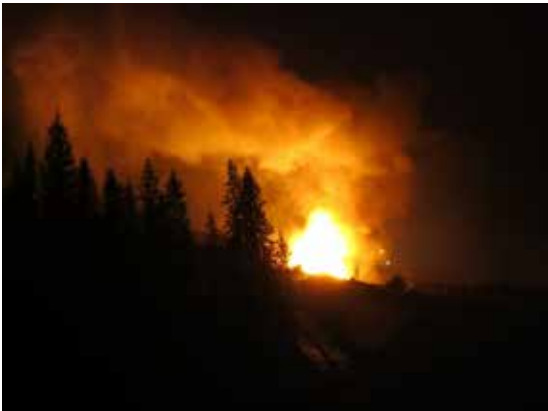
<p>Intensivering av brannen.</p>

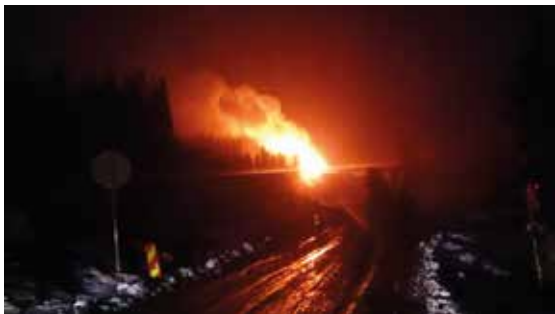
Kl 15:26 Brannen har vart i 2t 22 min	Bilde 8:

Intensivering av brannen.
Kl 15:26 Eksplosjonen	Bilde 9:

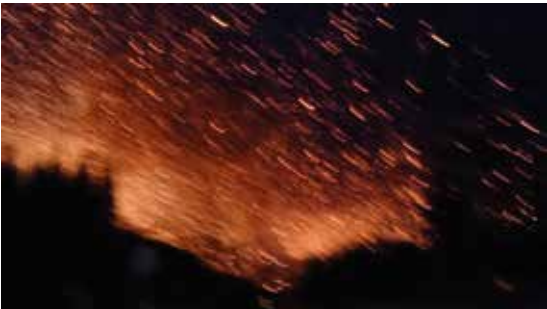
Brennende/glødende nedfall.
